## UTAH 3809 COMPLIANCE INSPECTION REPORT

*Project name:* Picture Spring Quarry (Picture Spring Claims 1 and 2)

*Date of Inspection:* October 13, 2010

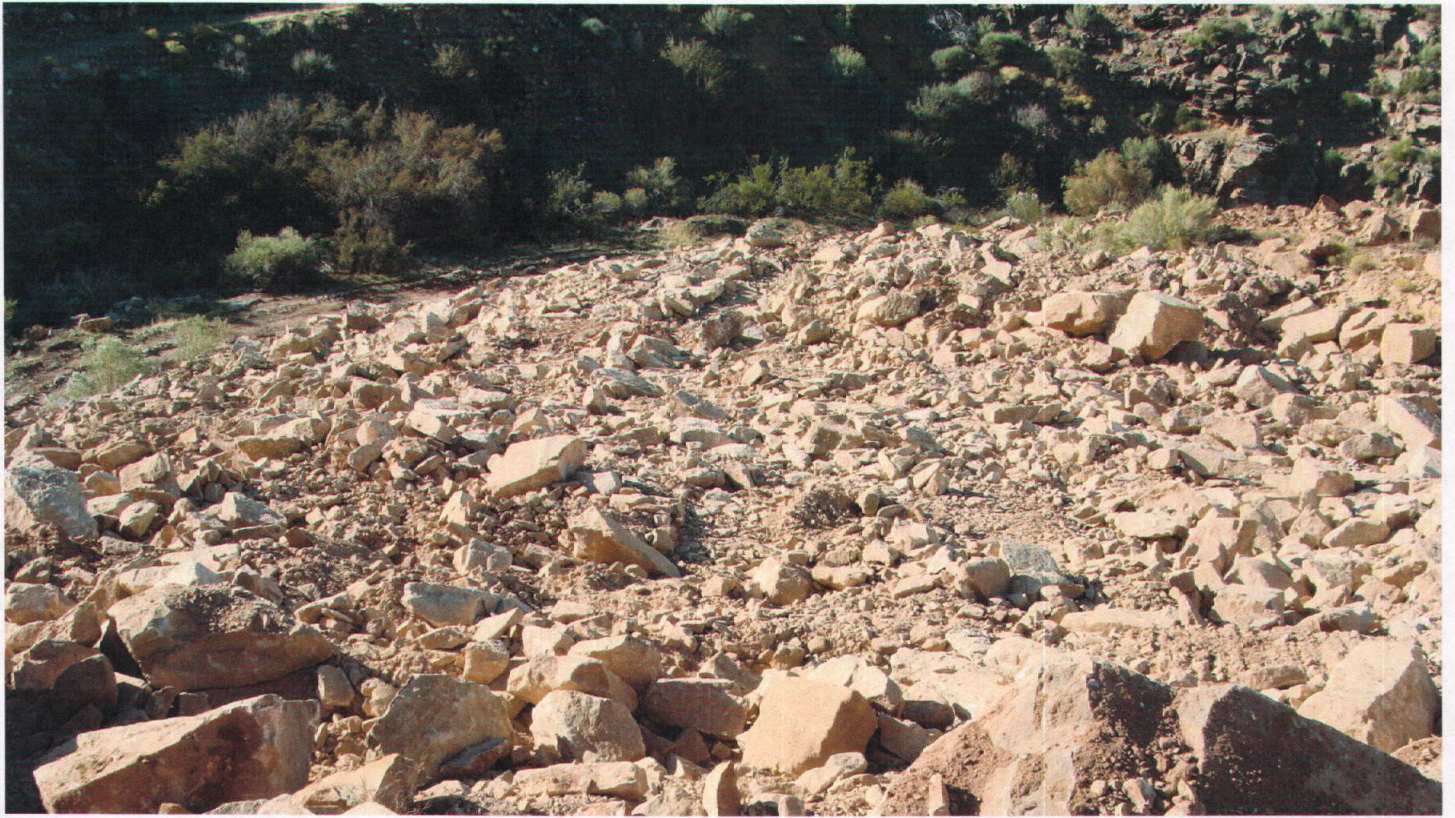
Overview of the quarry reclamation from the north edge of the pit, looking down toward the stream.

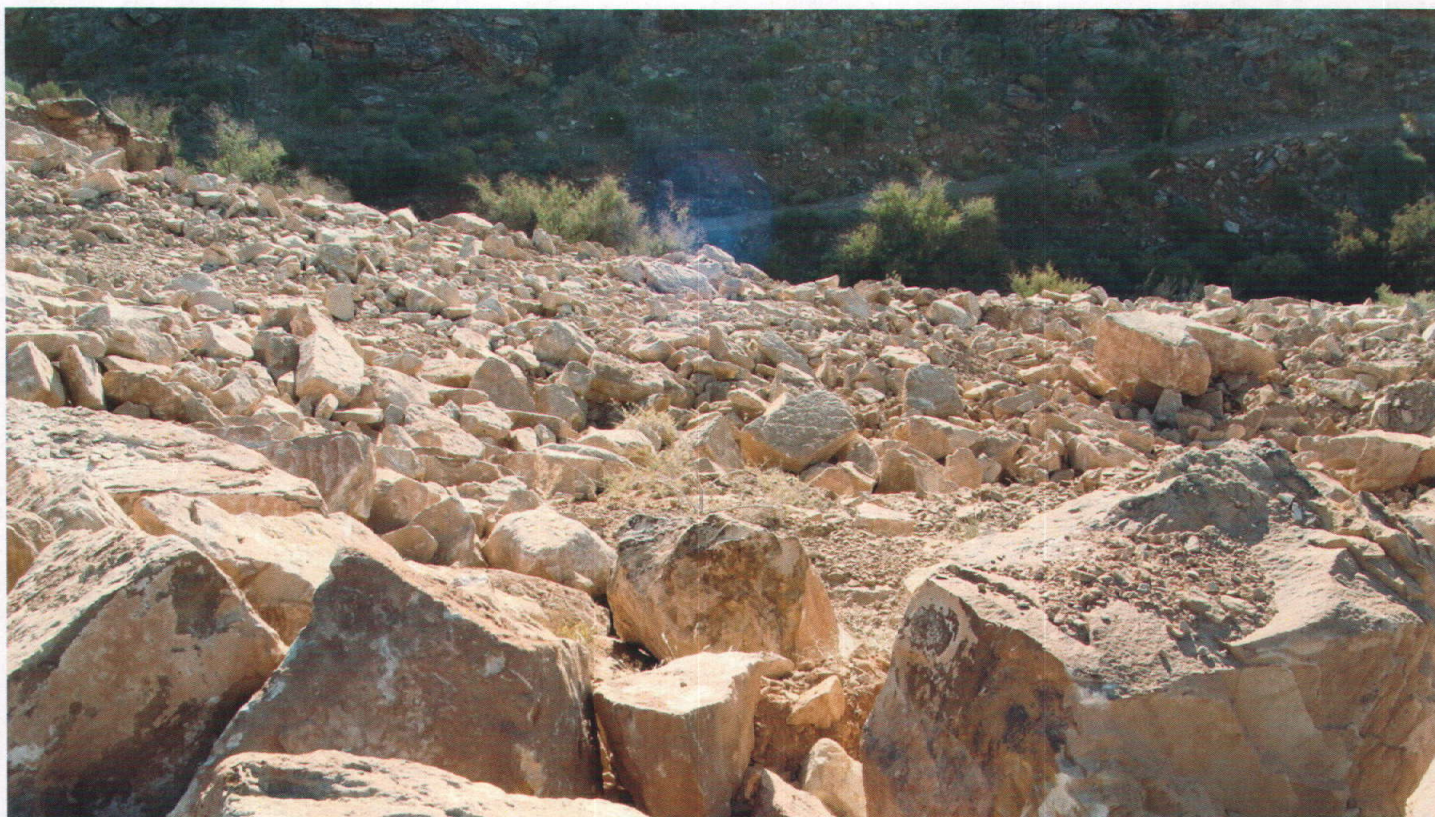
Overview of the quarry reclamation from the west edge of the pit, looking down toward the stream.

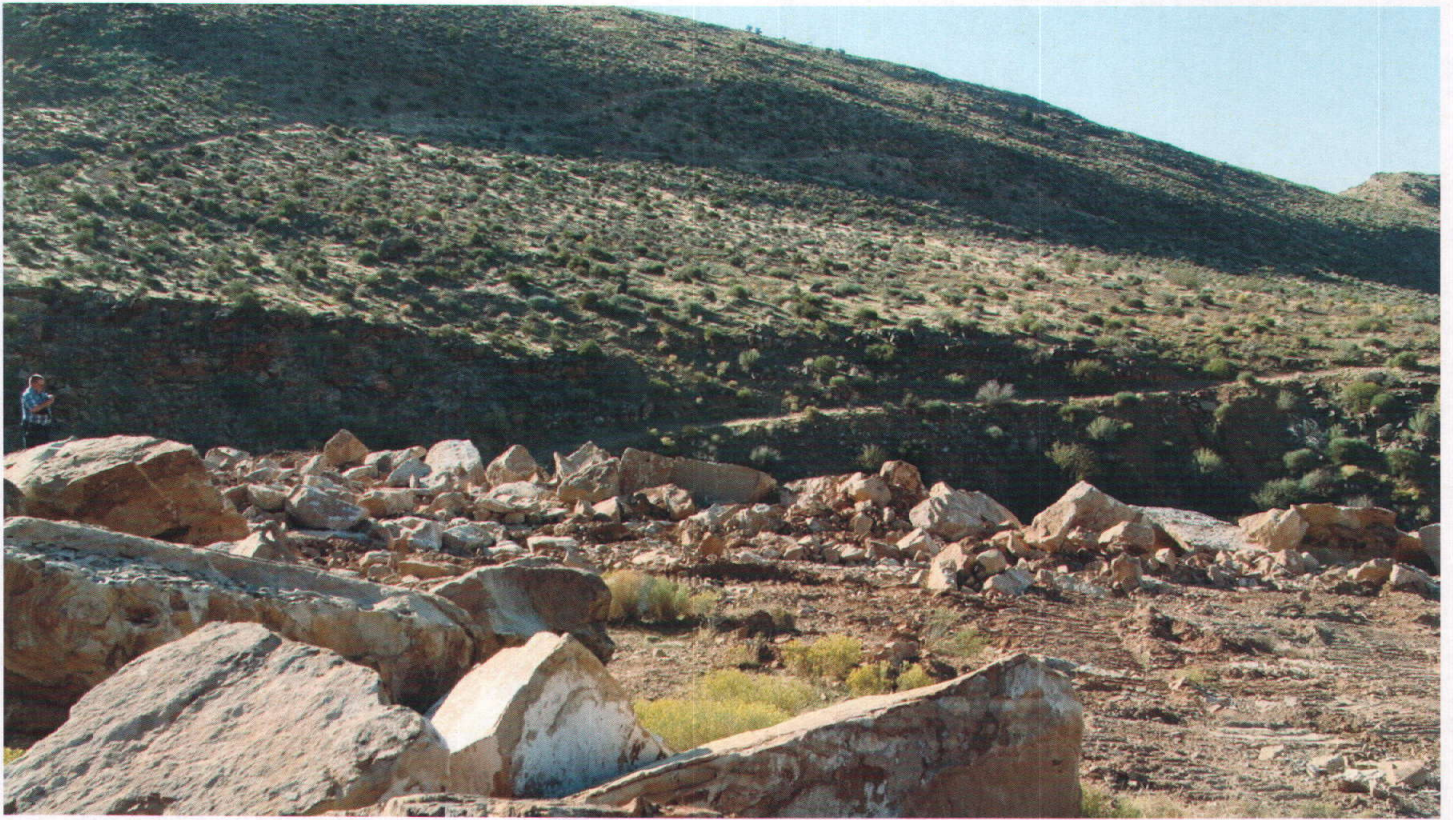
View of the area above the pit after reclamation work. Instructed operator to remove all rubble and the rock berm area into the pit and contour to slope. Some landscape boulders to be left for later removal or used by Thirstystone.

*Instructions to Operator:* Remove rock berm, blend rock-soil and contour to slope.

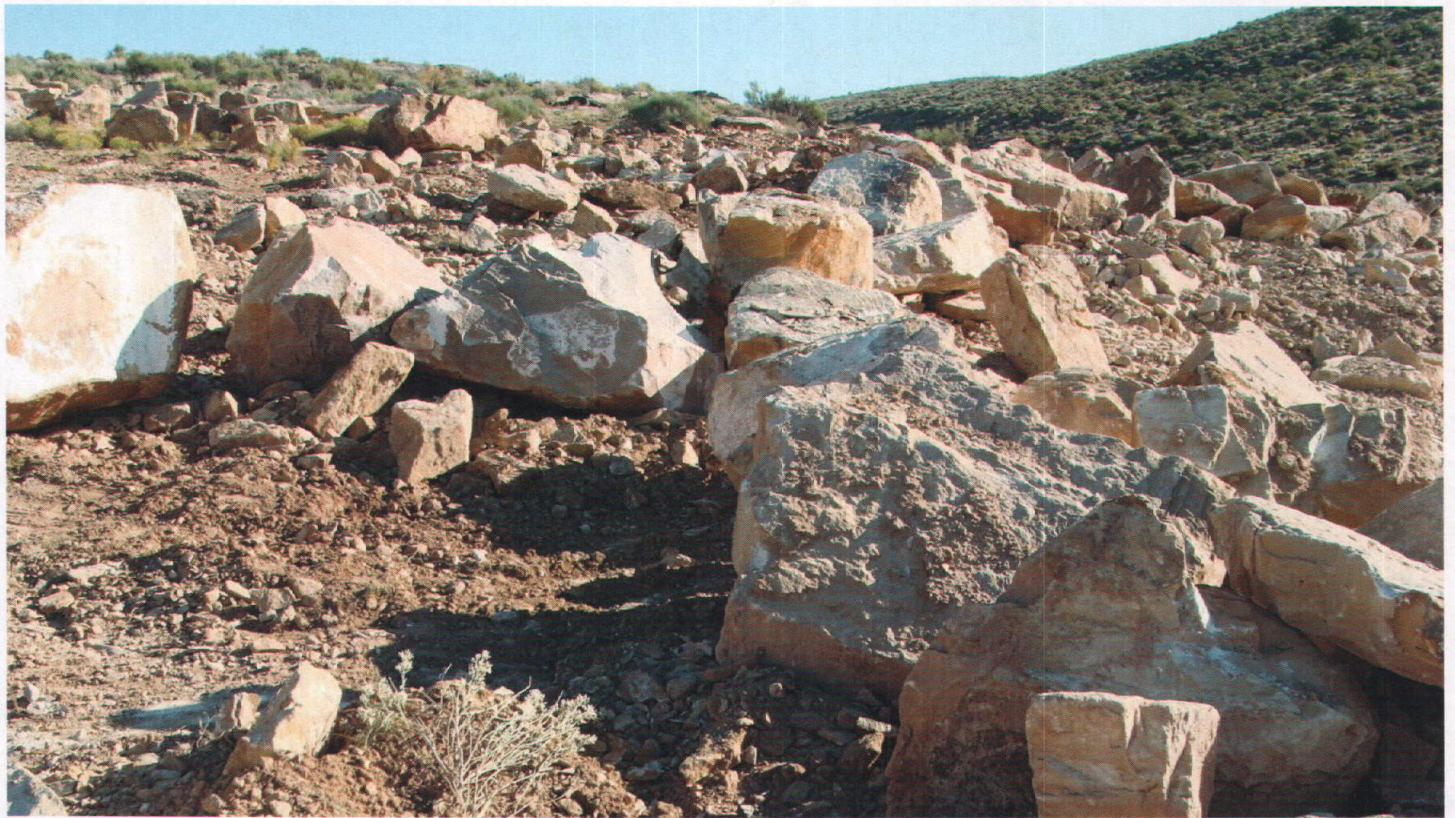
View looking north of the area above the pit after reclamation work. Instructed operator to remove all rubble and the rock berm area into the pit and contour to slope. Some landscape boulders to be left for later removal or used by Thirstystone.
